ROW# <u>C15-20 11-0048</u>

CITY OF AUSTE, ROW 10575808 APPLICATION TO BOARD OF ADJUSTMENT TROUBLE 00 1009 GENERAL VARIANCE/PARKING VARIANCE

STREET ADDRESS: 3207 Churchill Drive				
LEGAL DESCRIPTION: Subdivision —LOT 15 WESTWOOD RIDGE ADDN				
Lot(s)BlockOutlotDivisionN/A				
I/We Richard Archer on behalf of myself/ourselves as authorized agent for				
affirm that on <u>April</u> , <u>4</u>				
hereby apply for a hearing before the Board of Adjustment for consideration to:				
(check appropriate items below)				
ERECT ATTACH COMPLETE REMODEL _X_ MAINTAIN				
SF3 492(d) side yard setback encroachment of (1) one foot.				
NOTE: The Board must determine the existence of, sufficiency of and weight of evidence supporting the findings described below. Therefore, you must complete each of the applicable Findings Statements as part of your application. Failure to do so may result in your application being rejected as incomplete. Please attach any additional support documents.				
SF-3-hp				
Windsor Road N.P.				
N.P.

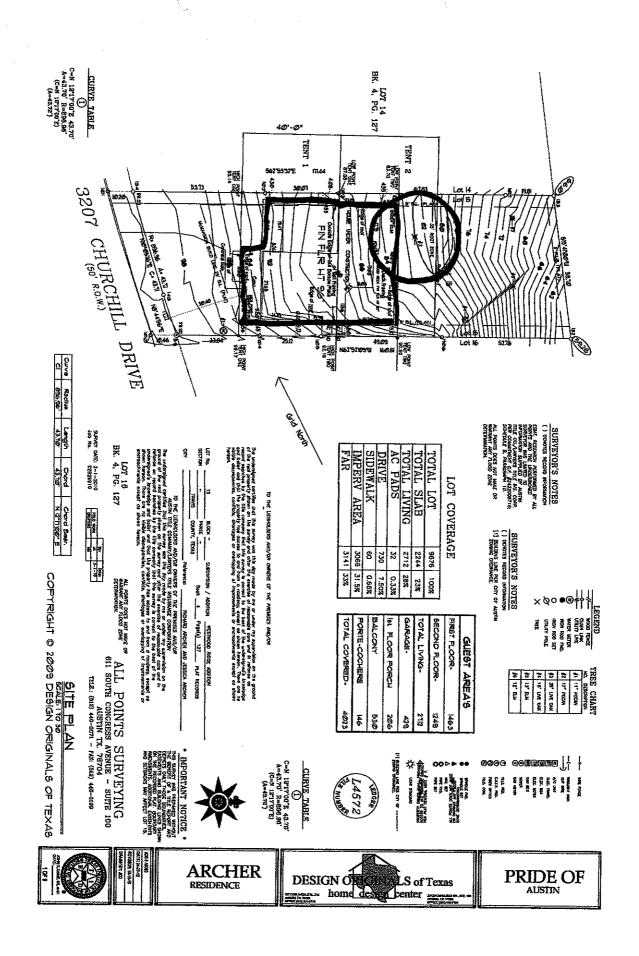
Figure OneRefer to the Key to Survey Markers and various notes on the following pages.

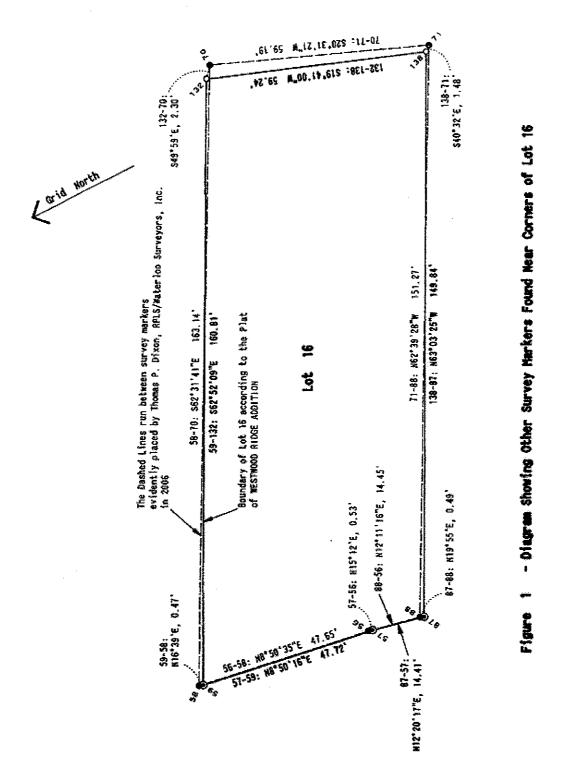
Figure 1 - Diagram Showing Other Survey Markers Found Near Corners of Lot 16

The markers numbered 71, 88, 56, 58, and 70 on the sketch were short lengths of 1/2 in. rebar, all but Rod No. 58 with plastic caps imprinted "WATERLOO, RPLS 4323" that had evidently been placed by Thomas Dixon, RPLS in 2006 to mark the boundaries of Lot 16, but in ignorance of the existence of the original Iron Pipes Nos. 87, 57, and 59 still remaining from O. Leonard's survey of the subdivision and in ignorance of the location of the North line of BRYKER-WOODS ADDITION "B" along which Mr. Leonard's map showed that he had laid out the South line of Lot 16. Mr. Dixon's erroneous markers are described in the Key to Survey Marks appearing on my Map No. 11-836.

All of The Dixon/Waterloo markers were found basically flush with the present surface of the ground and were relatively easy to find. Those along Churchill Drive had the practical effect of concealing the original Leonard pipes nearby, defeating the use of a metal detector to search for the buried original markers by masking their fainter magnetic signatures.

In addition to the survey markers shown upon my Map No. 11-836 as marking the boundaries of Lot 16, I found the other markers shown in the sketch appearing as Figure 1 on the following page.

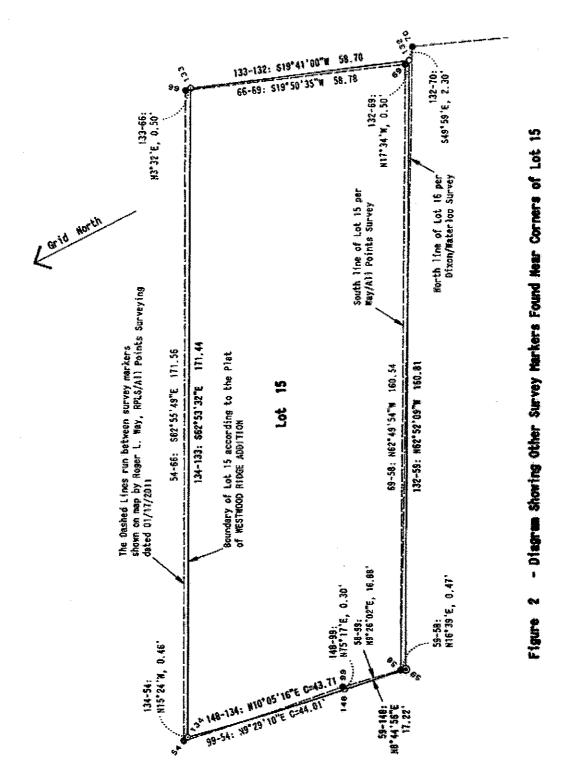
Figure 2 - Diagram Showing Other Survey Markers Found Near Corners of Lot 15

On the street front of Lot 15, I placed a new rod and cap marker No. 148 as shown upon my map to mark the beginning of an 896.96 ft. radius curve. Beside Rod and Cap No. 148, I found an old, bent 1/2 in. iron pipe in place, the center of the base of the pipe bearing N75°17'E, 0.30 ft. from the Rod and Cap as noted in the description of Rod and Cap No. 148 in the "Key to Survey Marks" on my map. I judged that this old pipe had most likely been disturbed or tampered with. The top of the pipe had fresh hammer marks on it suggesting that it had been driven into the ground relatively recently. The pipe fell beside a 4 x 4 sign post a home builder had recently placed. Prior surveys by others indicated that the pipe was not in the same position in which it had previously been reported. I judged that the pipe did not preserve the position in which Mr. Leonard had marked the corner and disregarded it, placing my new Rod and Cap No. 148 to correctly mark the corner.

I placed Rod and Cap No. 134 to mark the West common corner of Lots 14 and 15 as shown upon my map. Bearing N 15°24'W, 0.46 ft. from the Rod and Cap, I found an old, bent 11-inch long piece of 1/2 in. iron pipe that is designated as Pipe No. 54 on the "Key to Survey Marks". This pipe was 7 in. below grade and had been driven into gravelly fill material that I take to have been placed either during or after street construction. This pipe was apparently used in a survey of Lot 15 made for Richard and Jessica Archer by Roger L. Way, RPLS and All Points Surveying, however, the facts that the pipe:

Figure 2 on the following page shows the positions of the various corners of Lot 16 as determined by All Points Surveying in their second attempt in relation to where I find the major weight of the evidence places the corners of Lot 16 as shown upon the plat of WESTWOOD RIDGE ADDITION.
